DAM-BREAK FLOODS IN LOW ORDER MOUNTAIN CHANNELS OF THE PACIFIC NORTHWEST

Carol Coho
Stephen J. Burges

Water Resources Series
Technical Report No.138
June 1994

**Project Completion Report for the Award
"An Examination of the Forms of Initiation of
Floods From the Breaching of Non Engineered Dams"
Administered by the State of Washington
Department of Natural Resources
Timber Fish & Wildlife
TFW-SH9-93-001**

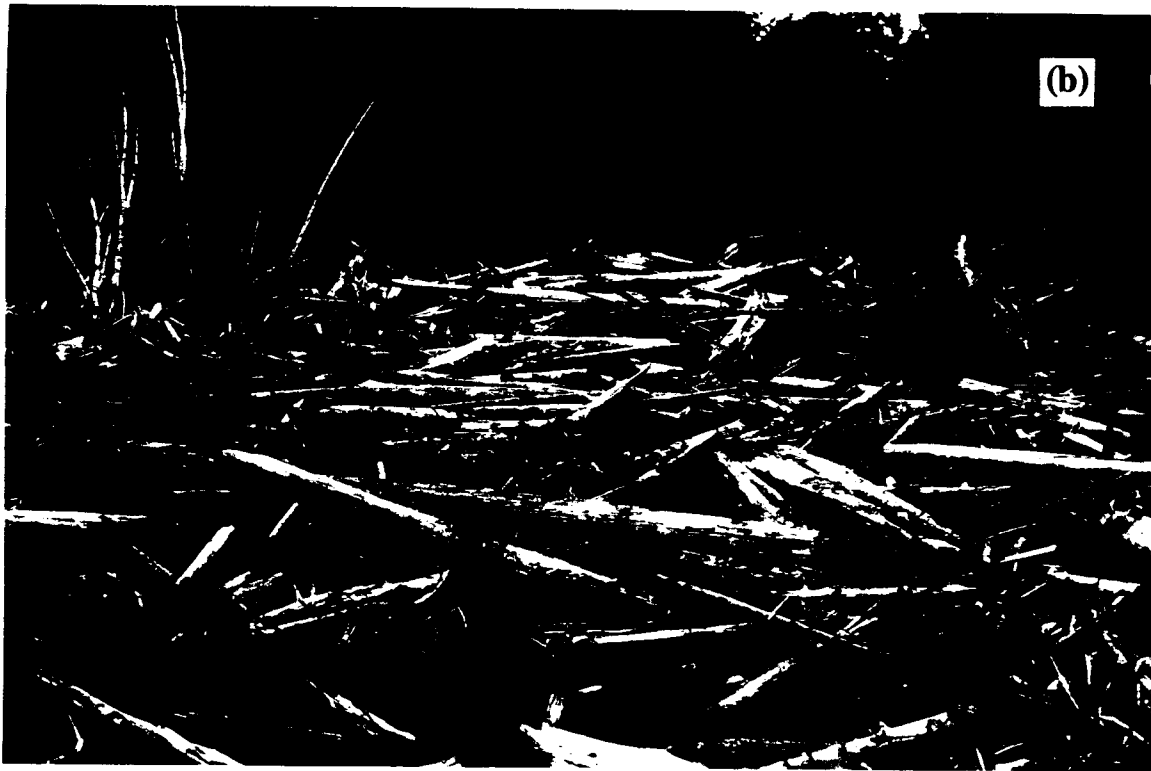
Fig. 4.6 a) Upstream and b) downstream views of Huckleberry Creek immediately upstream of dam terminus (approximate elevation 200m).
