HYDROLOGIC RESPONSE OF RESIDENTIAL- SCALE LAWNS ON TILL CONTAINING VARIOUS AMOUNTS OF COMPOST AMENDMENT

Water Resources Series
Technical Report No. 147
September 1995

Project Title: Improved Residential Onsite Stormwater Management

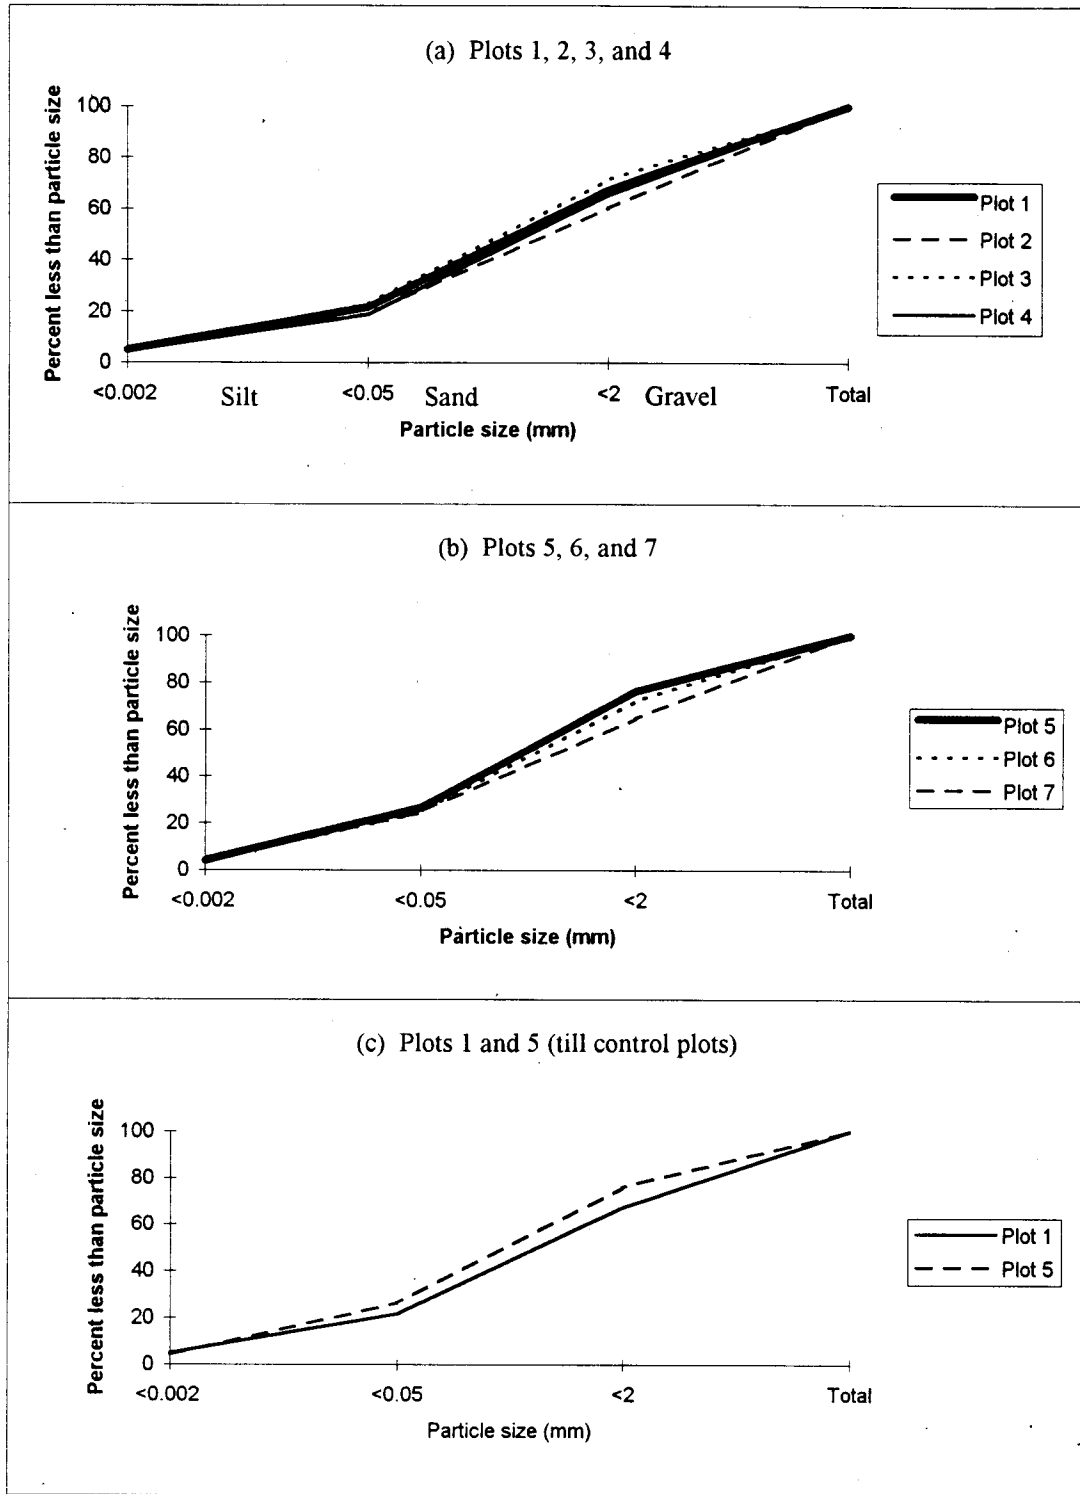
Figure 3-10: Cumulative particle size distributions

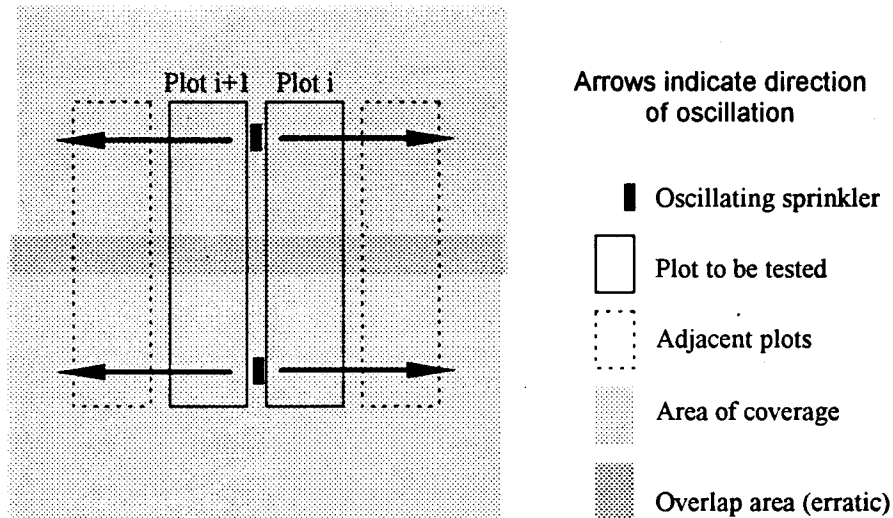
Figure 6-1: Plan view schematic of placement and coverage of sprinklers

the areal extent of this region was small and the overall distribution pattern was relatively uniform. The overlap of the sprinkler coverages and wind interference made completely spatially-uniform synthetic rain patterns unattainable.
